2022 HRC Anomaly Status – CUC Briefing

Dan Patnaude

11/28/2022

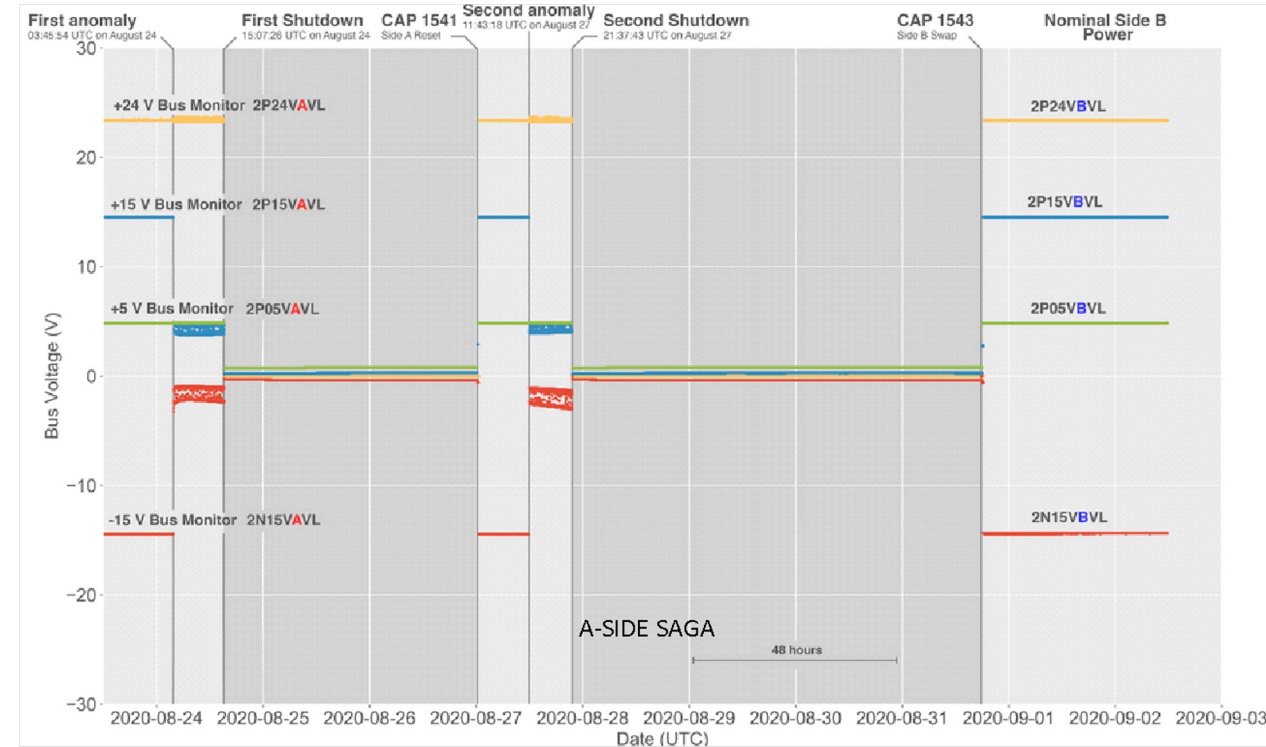
- Side-A Anomaly – A1 (August 25, 2020):
 - Anomaly state A1:
 1. $\pm 15V$ voltage magnitudes out of spec with LOW values
 2. $\pm 15V$ buses exhibited high noise levels
 3. -15V level appeared to slowly trend back towards a higher value
 4. All SSD telemetry went out of spec due to a loss of analog power to secondary science data processors
 5. CEA was at normal operating temperatures ($\sim 25C$) prior to entering the anomalous condition
 6. FEA temperatures dropped, while CEA temperatures rose
 - Assumed a single event latchup and performed a restart
 - System operated for several hours before re-faulting with nearly identical symptoms

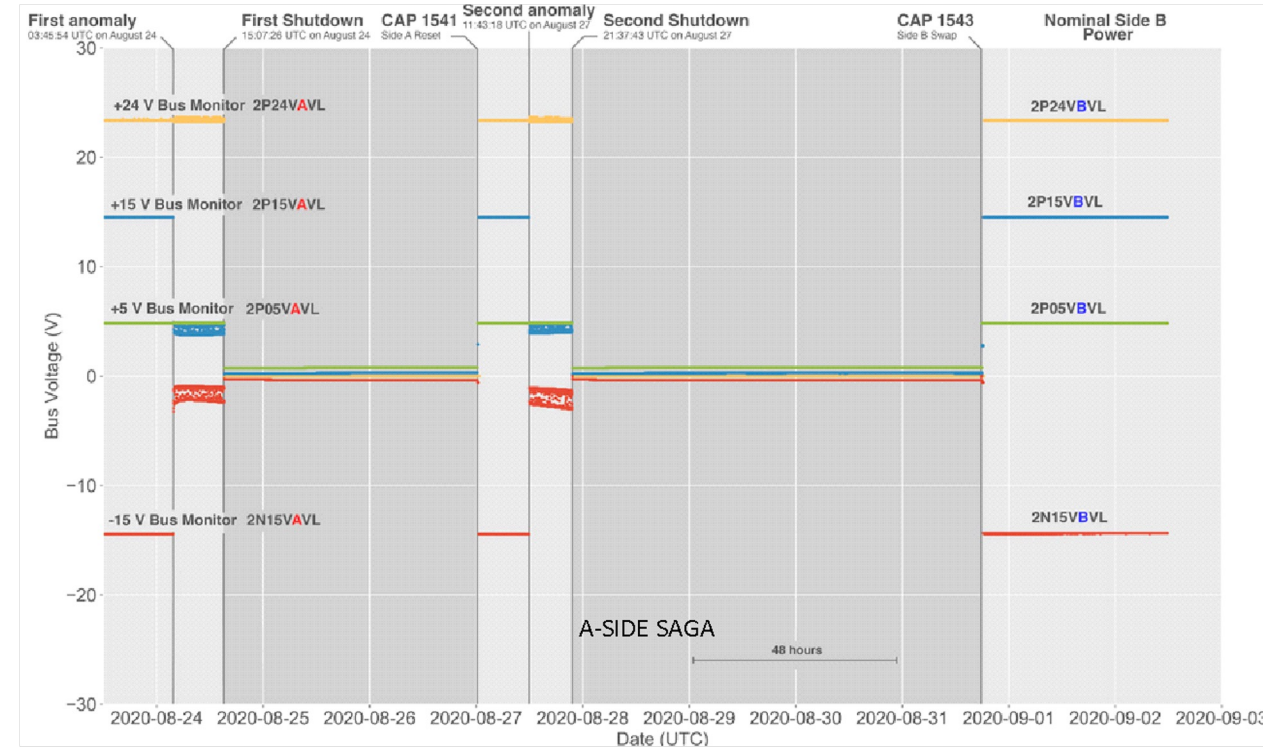
- Side-A Anomaly – A2 (August 27, 2020):
 - Anomaly state A2:
 1. $\pm 15V$ voltage magnitudes out of spec with LOW values
 2. $\pm 15V$ buses exhibited high noise levels
 3. -15V level appeared to slowly trend back towards a higher value
 4. All SSD telemetry went out of spec due to a loss of analog power to secondary science data processors
 5. CEA started cold and rose to a temperature of 12C before returning to the anomalous state
 - Remained in the anomalous state for approximately 11 hours
 6. FEA temperatures dropped, while CEA temperatures rose
 - Return to the faulted state on Side-A led the team to power down and perform a swap to Side-B

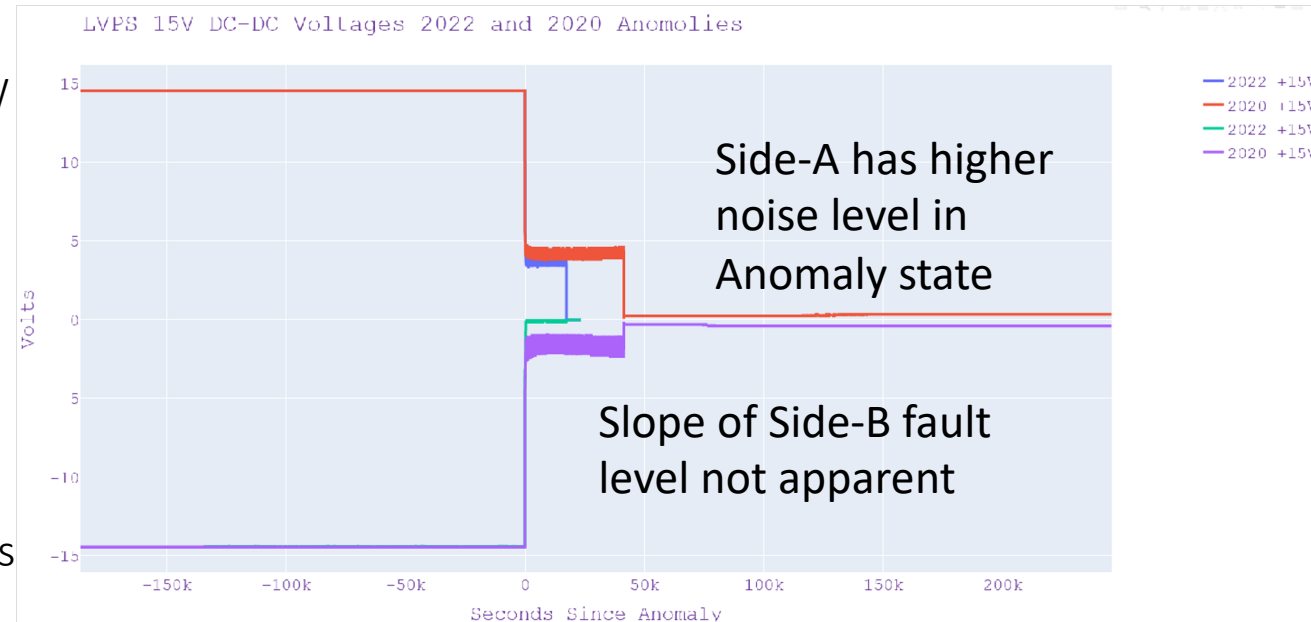
- Side-B Anomaly – B1 (February 9, 2022):
 - Anomaly state B1:
 1. $\pm 15V$ voltage magnitudes out of spec with LOW values
 2. +15V bus exhibited a “two-step” behavior – rapid drop to $\sim 4.5V$ followed by a decrease to 3.5V
 3. -15V level also exhibited a “two-step” drop
 - The two-step drop is interpreted as the inverting op-amplifier stage shutting down due to low +V
 4. All SSD telemetry went out of spec due to a loss of analog power to secondary science data processors
 5. CEA was at normal operational temperatures prior to entering the anomalous state
 6. FEA temperatures dropped, while CEA temperatures rose
 - Attempted a restart of the Side-B, which was unsuccessful (March 11, 2022)

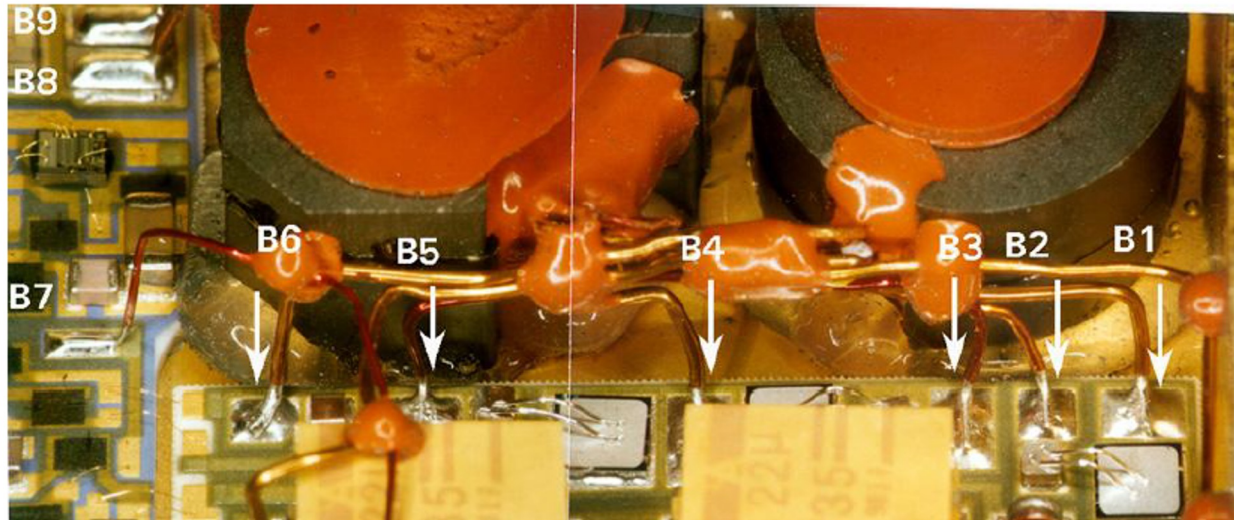
Figure 15. Overall internal view showing different solder joints. Note a lack of stress relief at bonds B3 and B6.

De-lidded MTR part showing internal magnetic components wired to carrier board - some with poor strain relief.

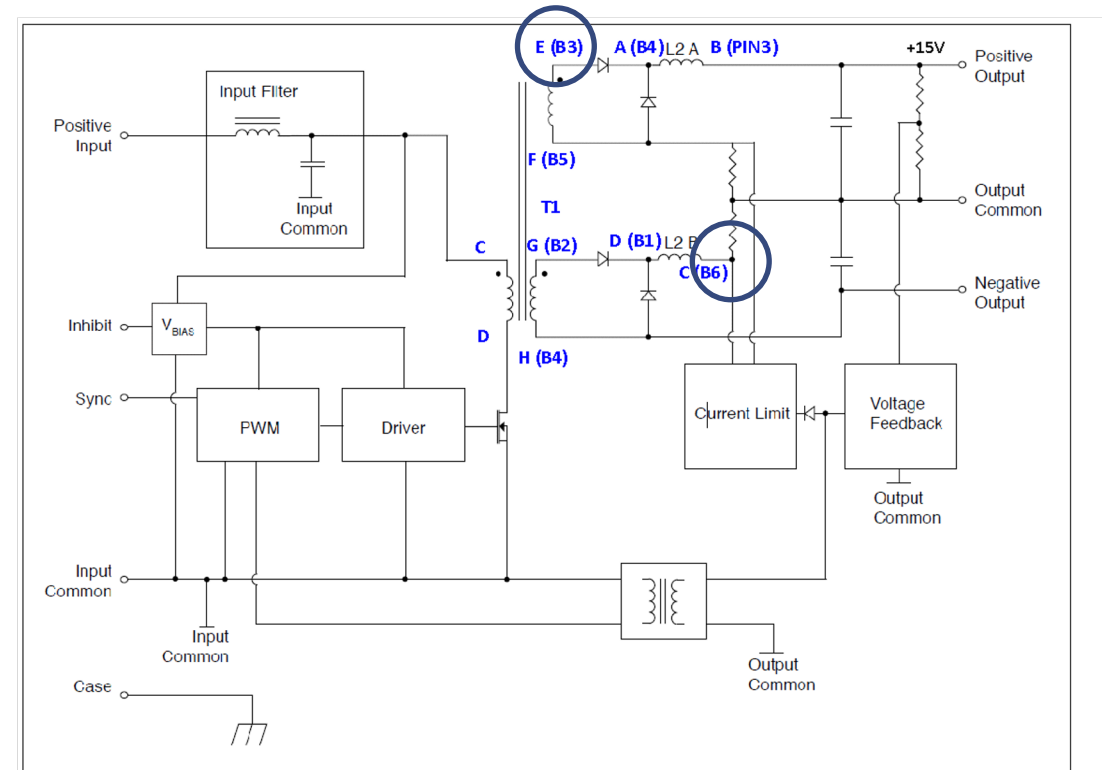
FIGURE 2: MTR DUAL /883 BLOCK DIAGRAM

Crane-Interpoint MTR Dual DC-DC converter Block Diagram w/references to device solder joint locations in previous figure. From: MTR (40 Series Datasheet) – Solder joints B3 and B6 circled

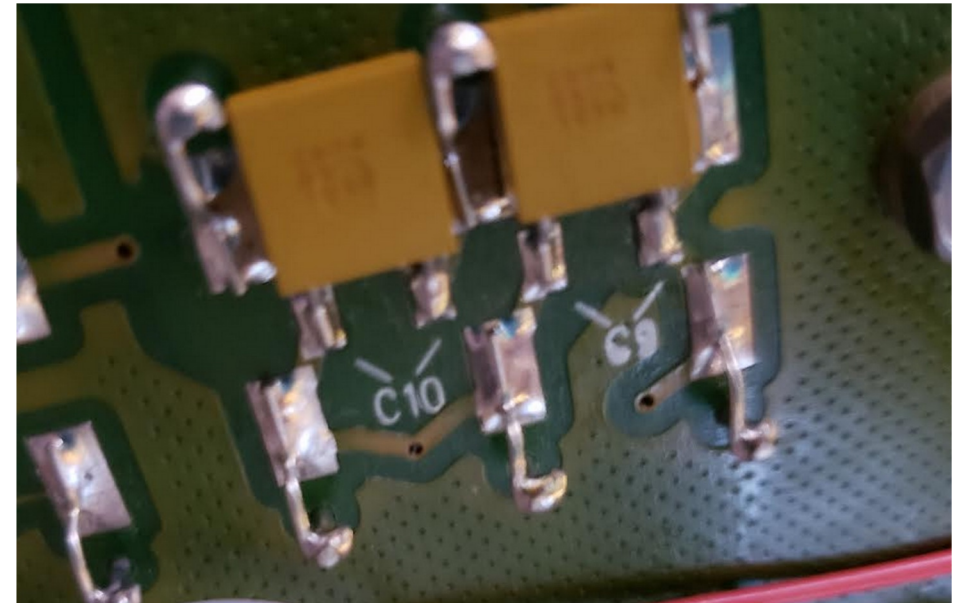
MLCC's on EM LVPS PWA

- Multi-Layer Ceramic Capacitor (MLCC) 50V, 1 μ F (M39014/02-1419)
 - There is one of these from each MTR2815D converter output in the CEA to filter out switching noise. There is no current limiting resistor in place

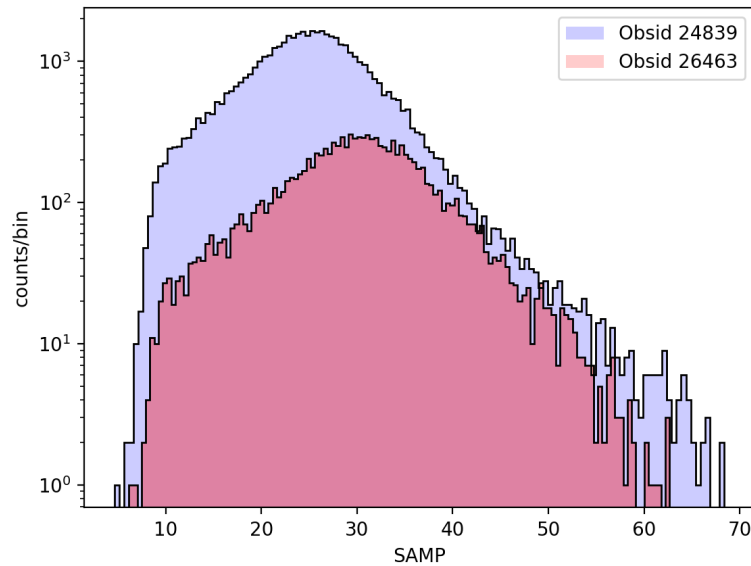
- First checkout observation of Capella (HRC-S)
 - PHA and SAMP (a derivative of PHA and amplifier scaling factor) show that signal distributions are consistent with pre side-B anomaly
 - Shift to higher SAMP is a result of Spring 2021 HRC-S HVPS increase
 - SAMP distribution has not been normalized for difference in exposure times

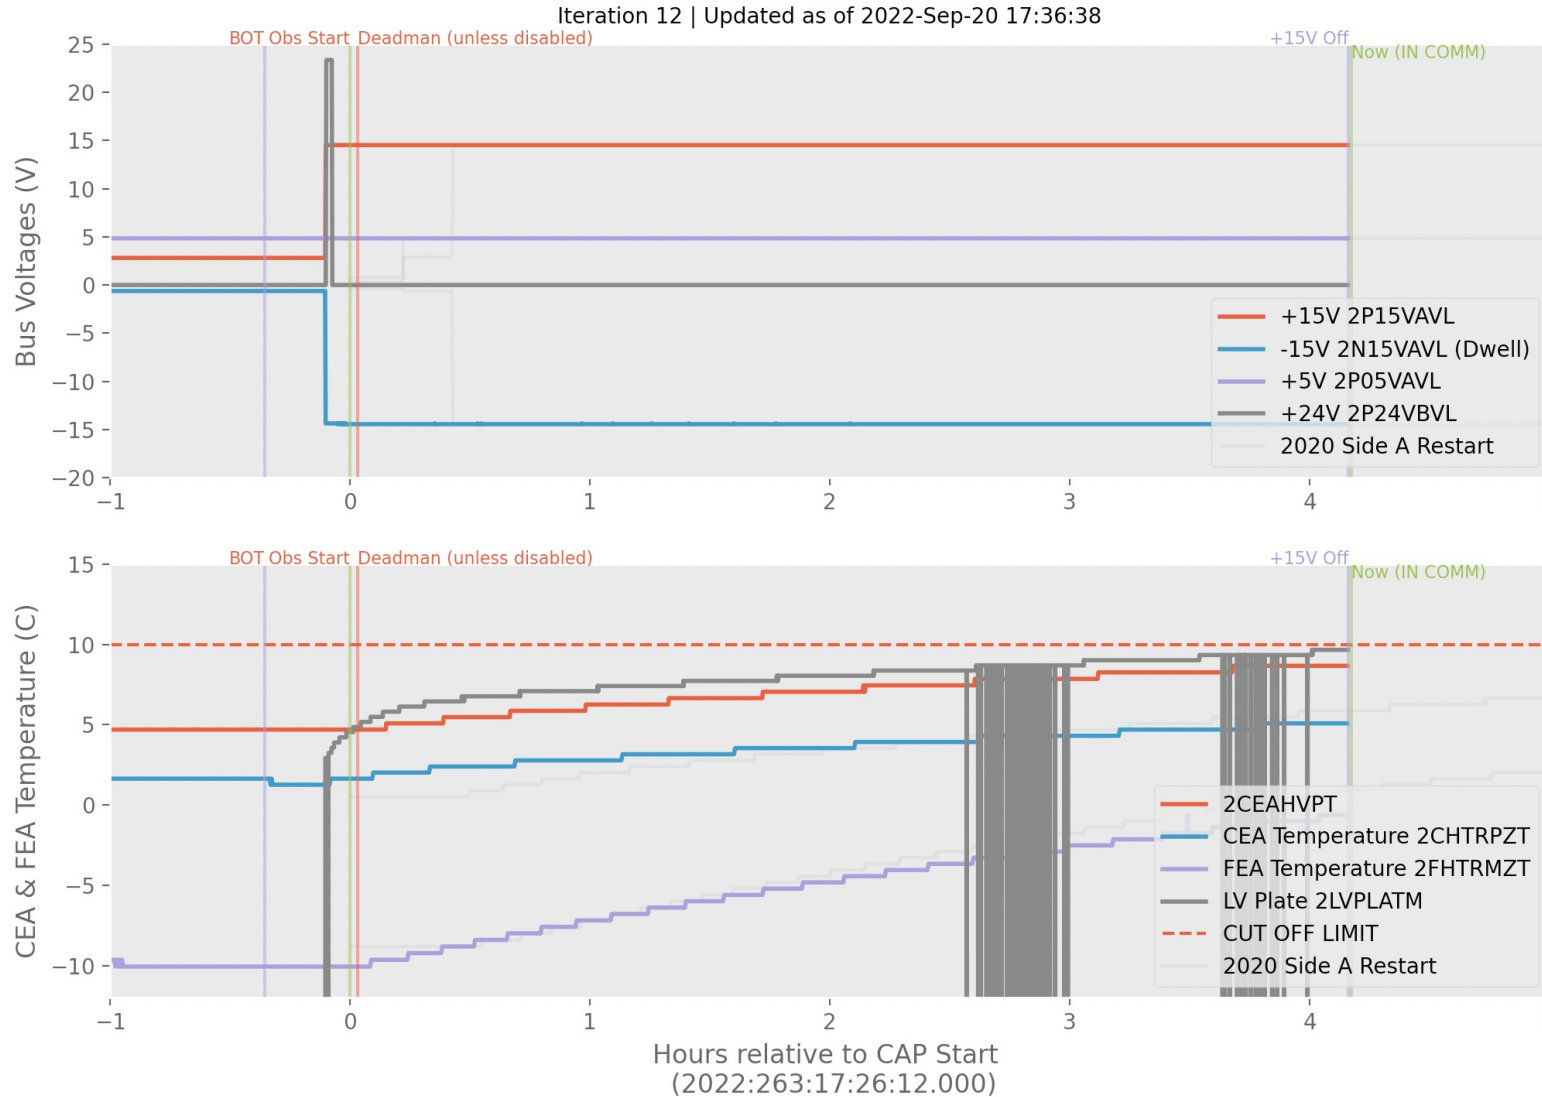
2CEAHVPT as a proxy for 2LVPLATM

- 2LVPLATM is located on HRC LV board
 - only available when $\pm 15V$ is powered and nominal
 - 2LVPLATM is susceptible to secondary science corruption
- 2CEAHVPT is located on the HVPS bracket and close to LVPS board
- Heating rate of HVPS bracket is functionally similar to heating of LVPS board (lower panel, red curve vs. gray curve)
- Data are from [fourth checkout observation](#)
