# HRC - Y Shutter Anomaly

Michael Juda for the HRC Team

## -Y shutter failed to insert for ObsID 3831

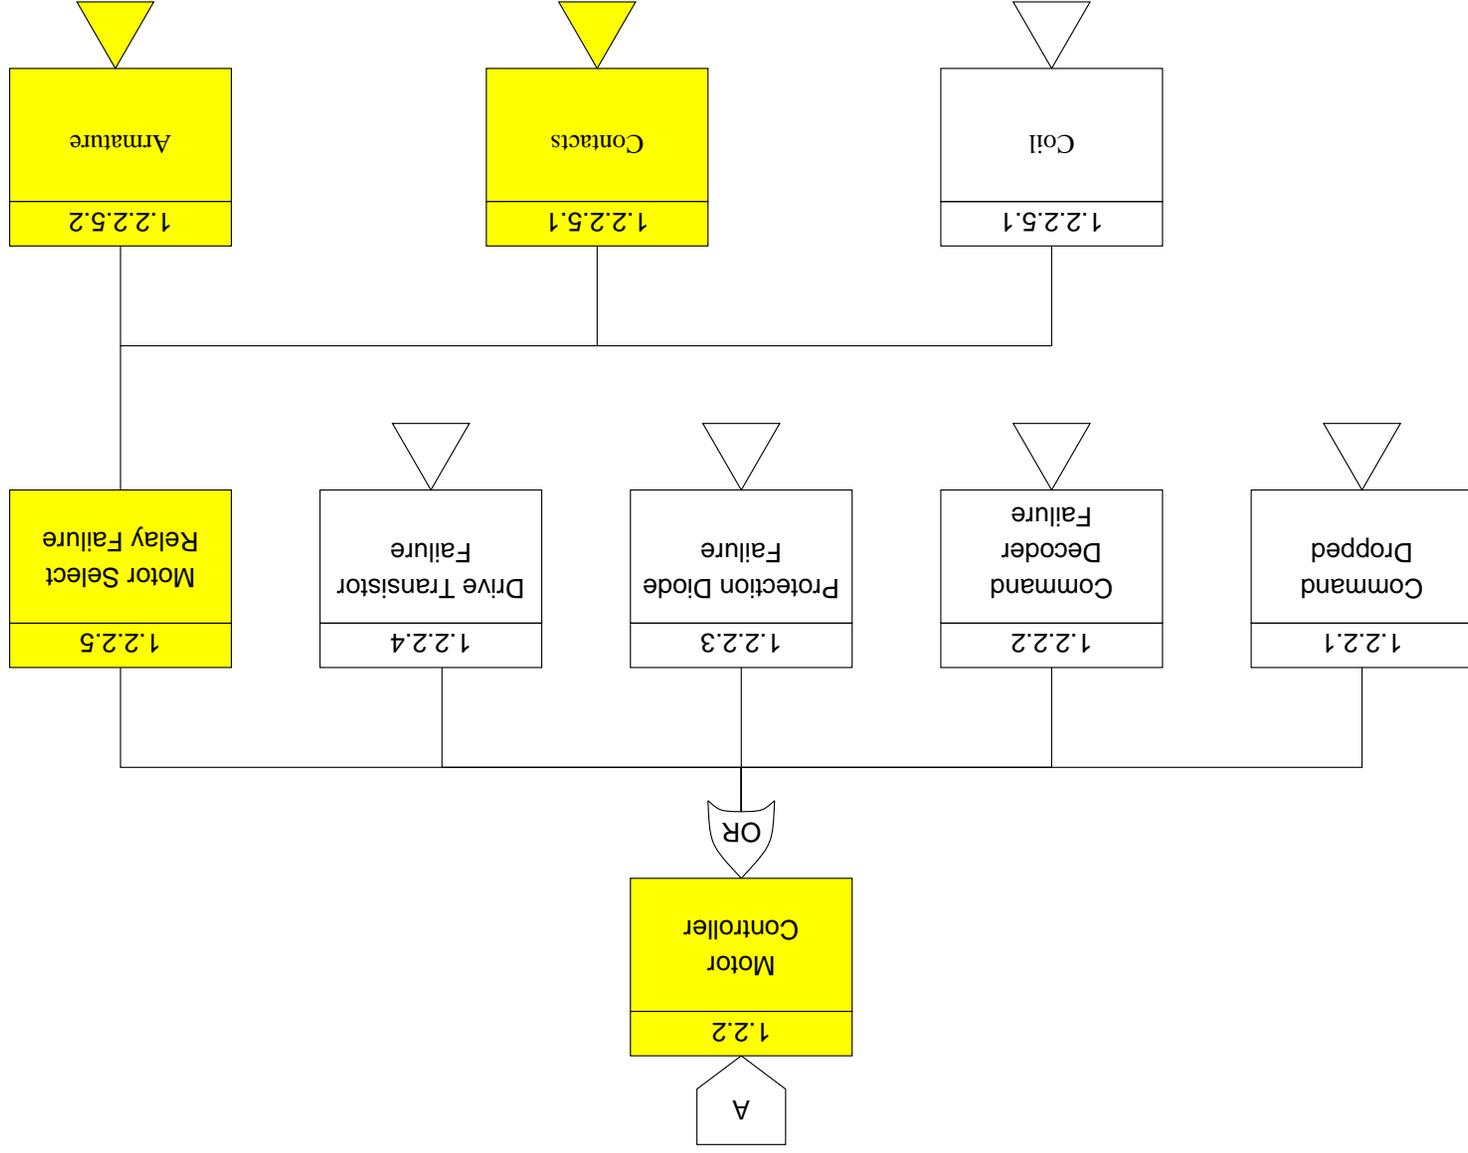
# Fault Tree - HRC Motor Controller

Verified that slight increase in the HRC bus current indicates that the coil for the -Y shutter motor select relay was energized but that the relay did not switch.

**Fault traced to a problem with the relay armature or contacts**

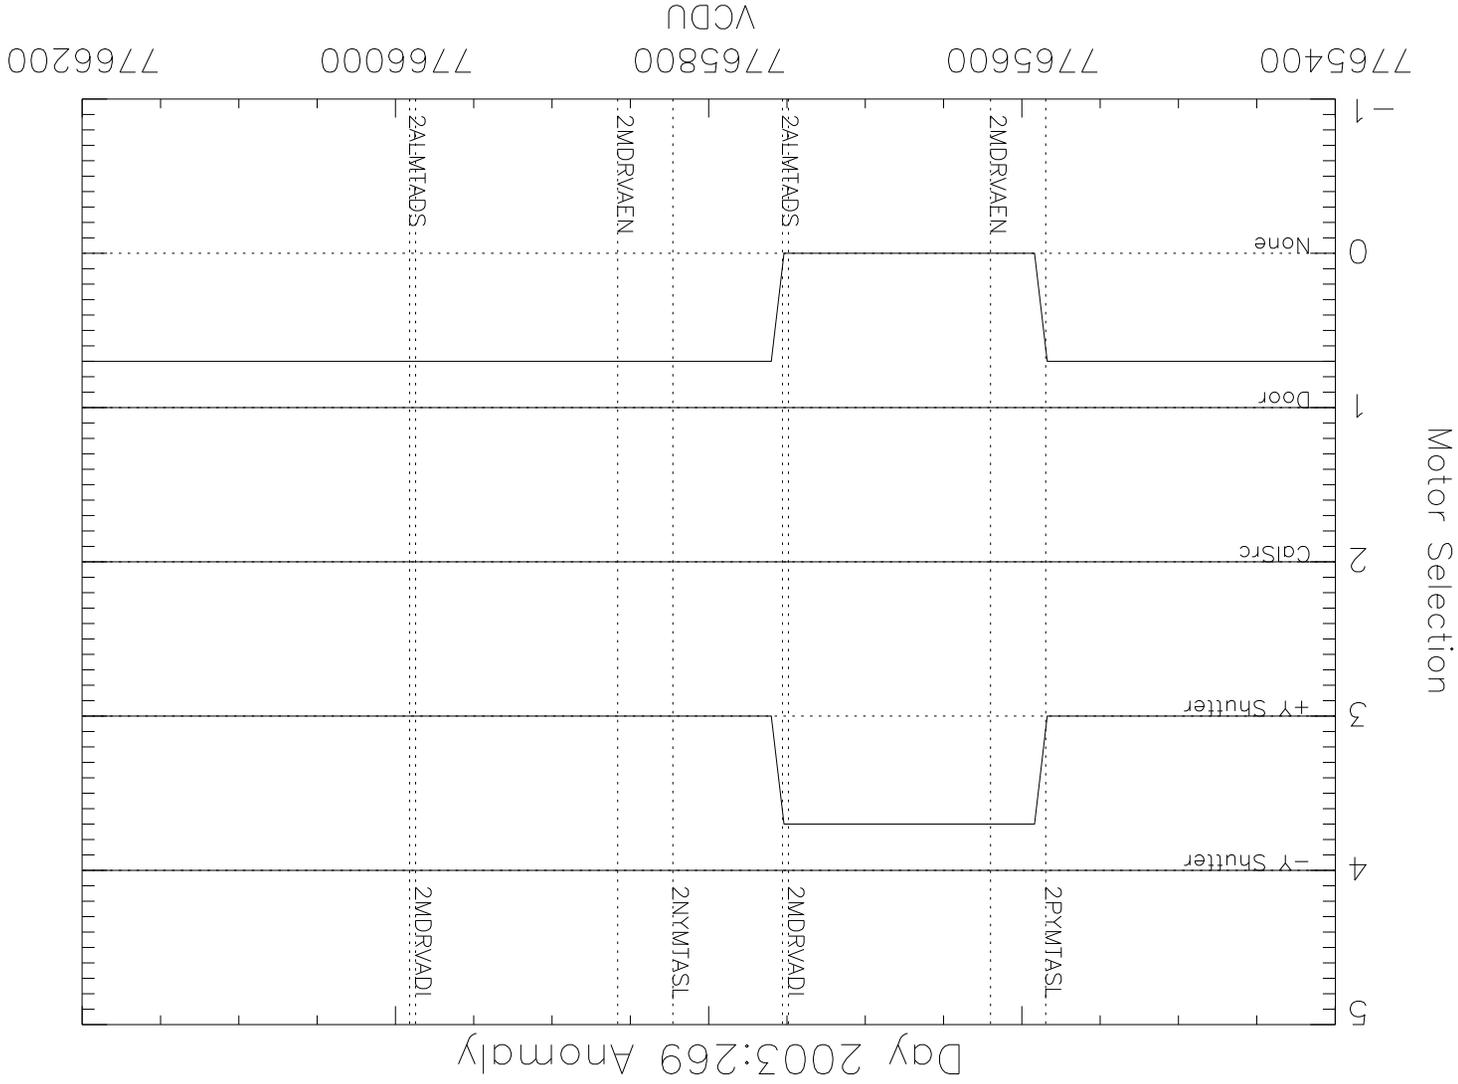
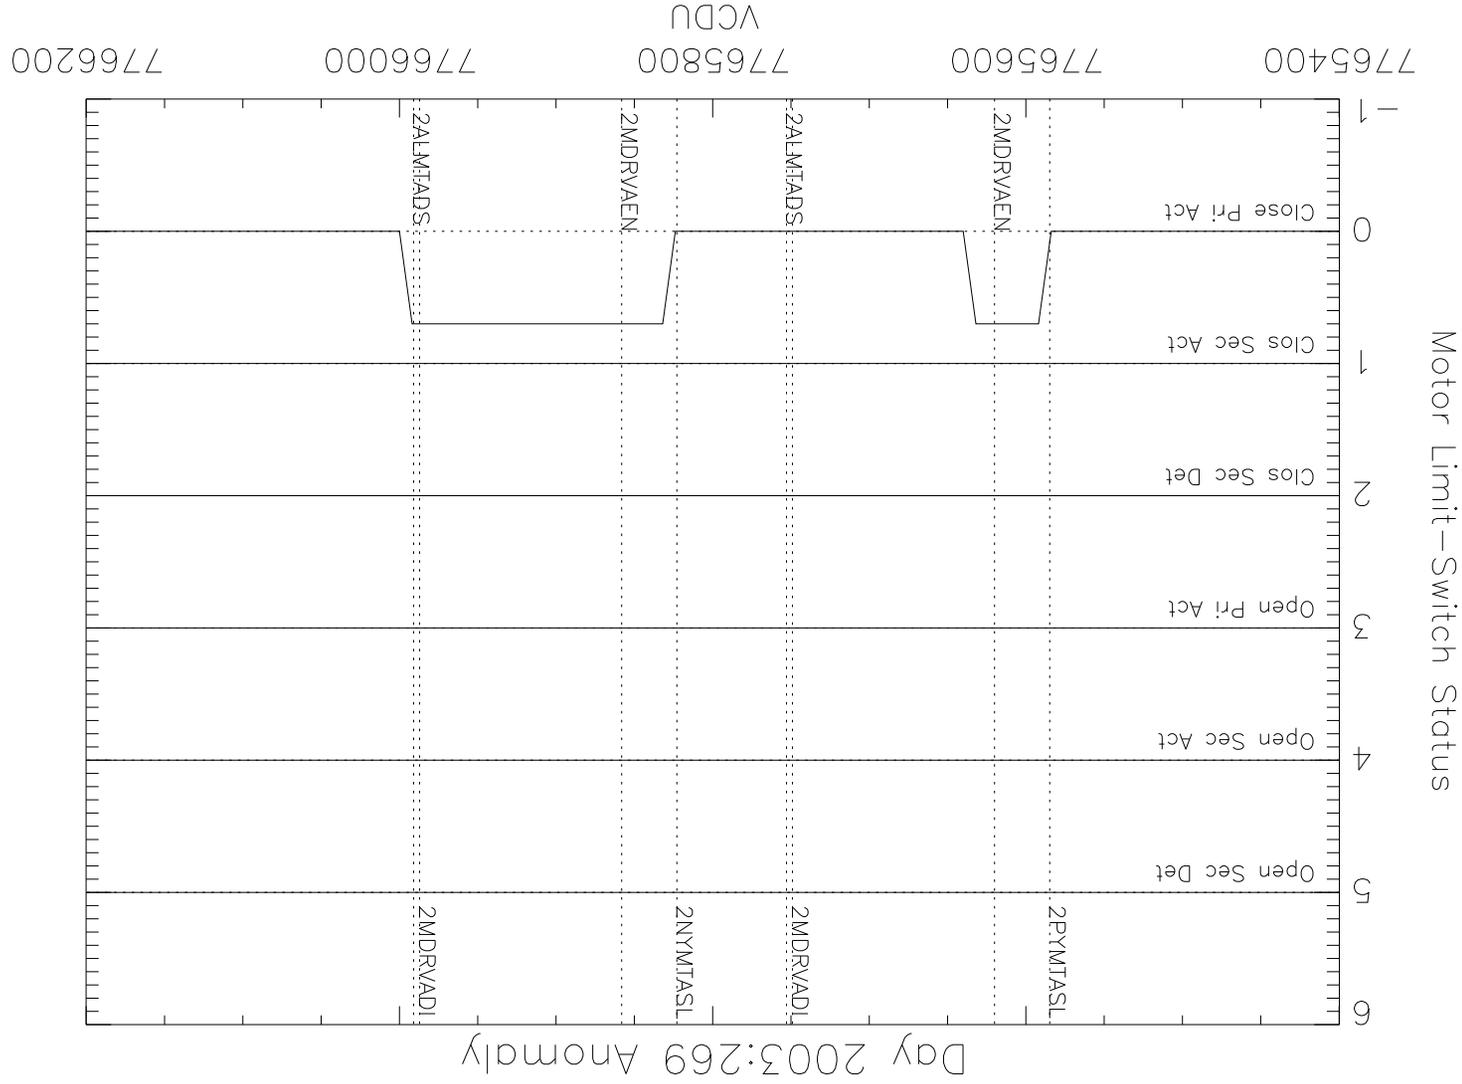
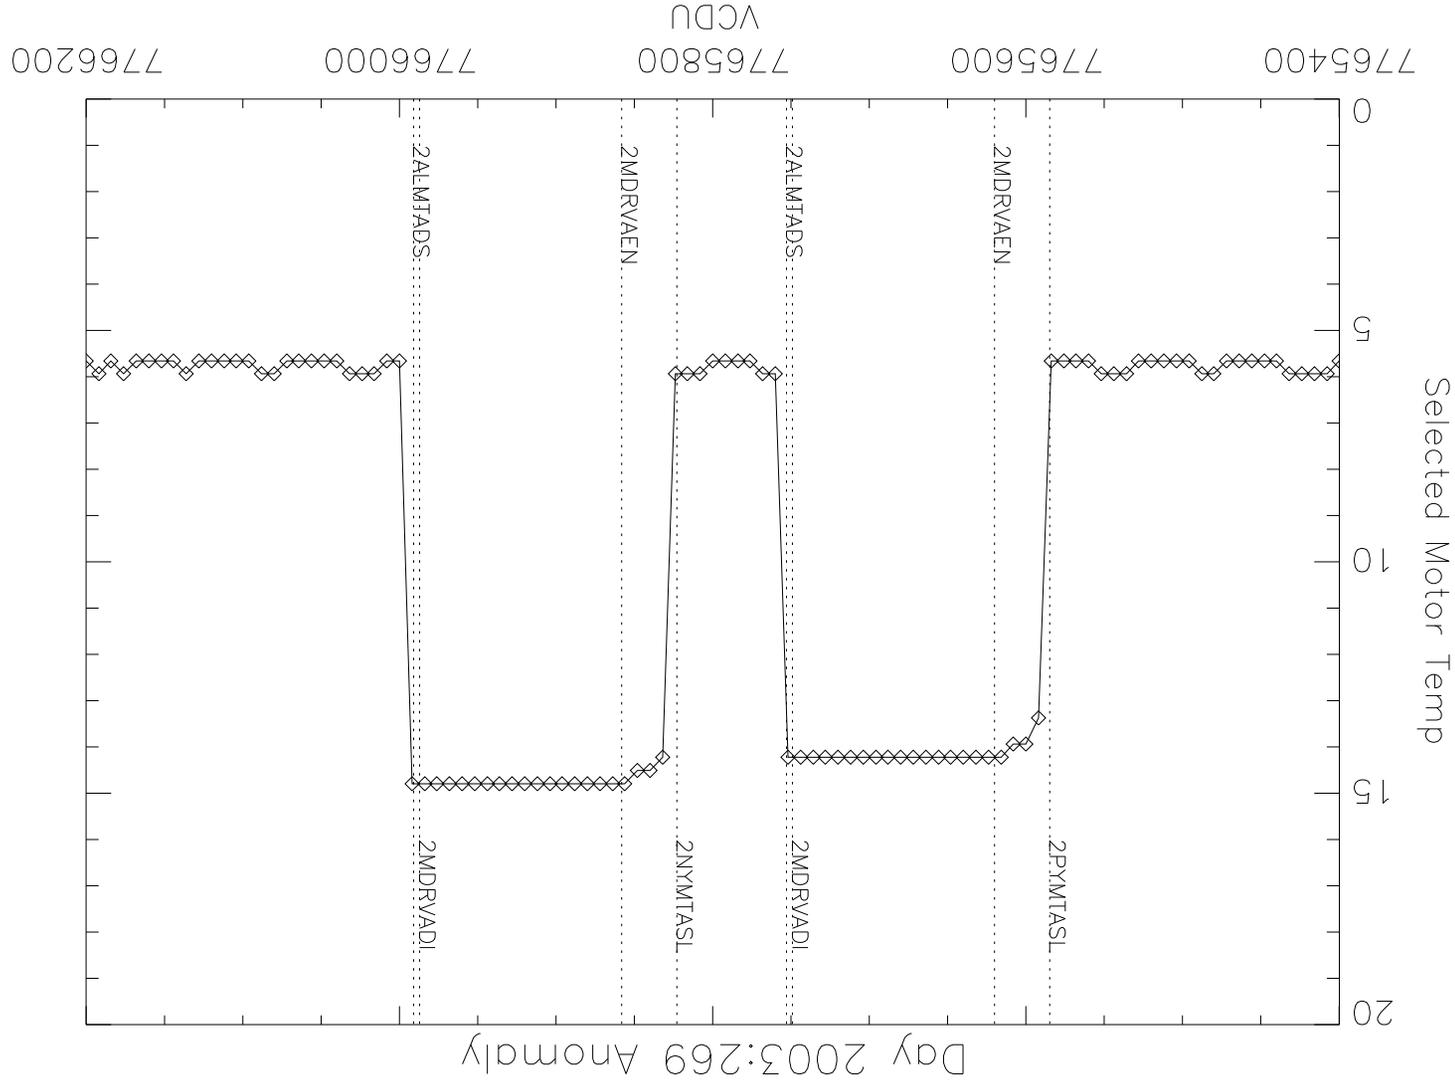
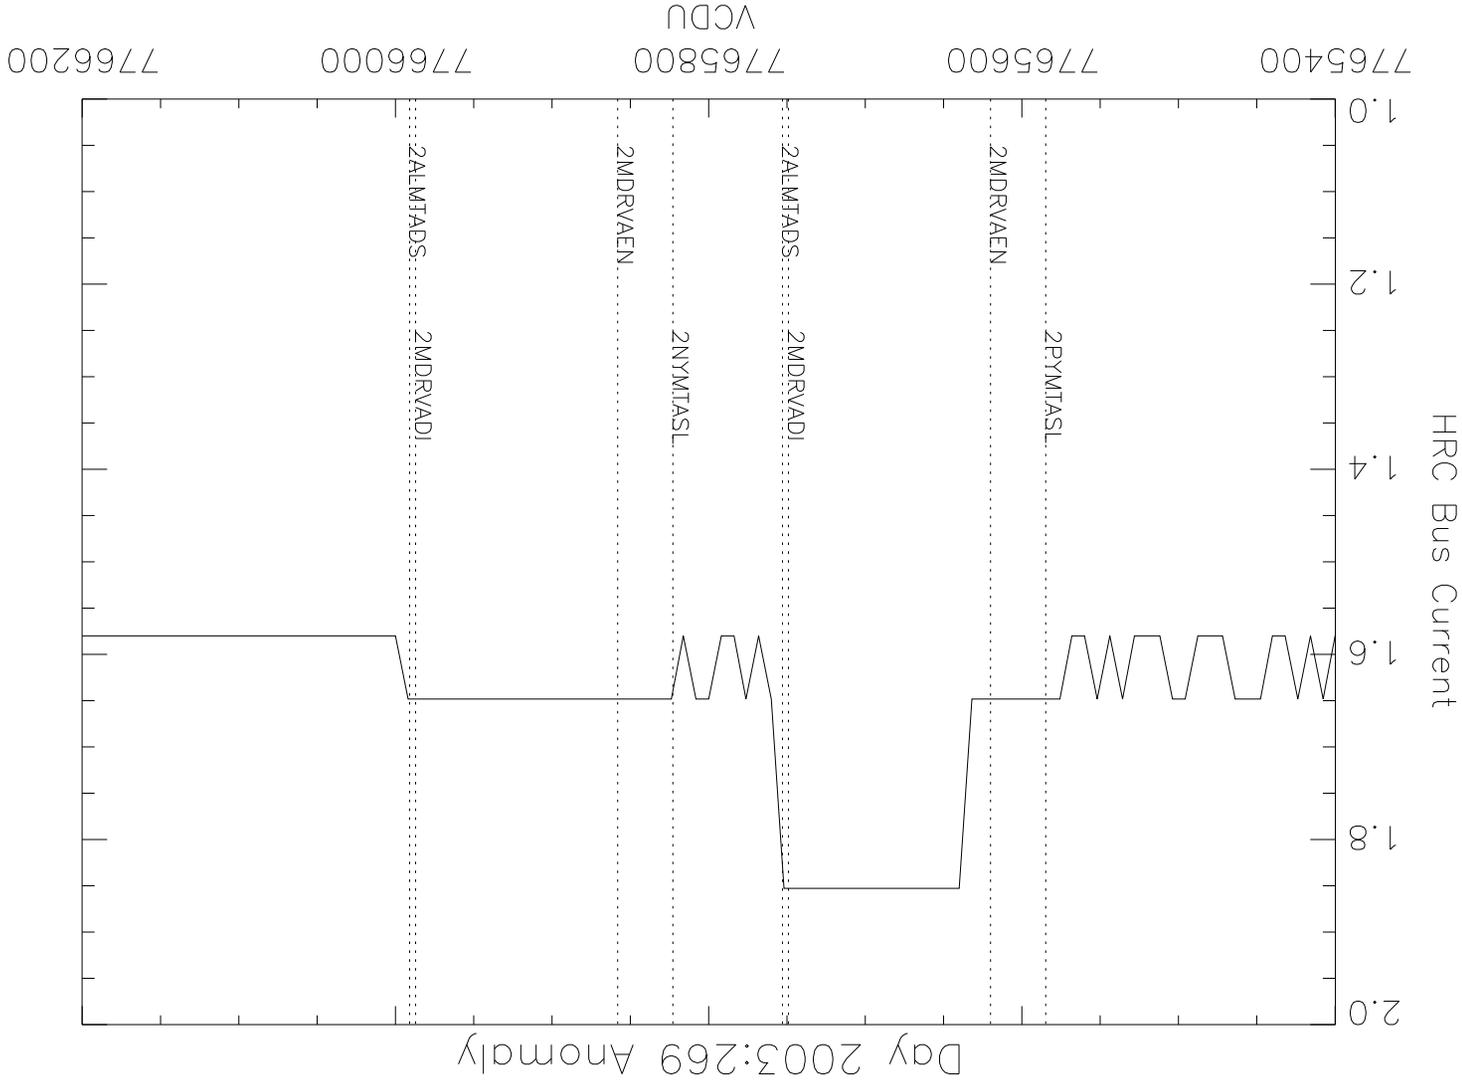
HRC received -Y shutter selection command and acted on it.

- -Y shutter limit switch set selected
- -Y shutter motor thermistor selected
- HRC bus current increased

However, -Y shutter motor selection was not indicated and shutter did not move.

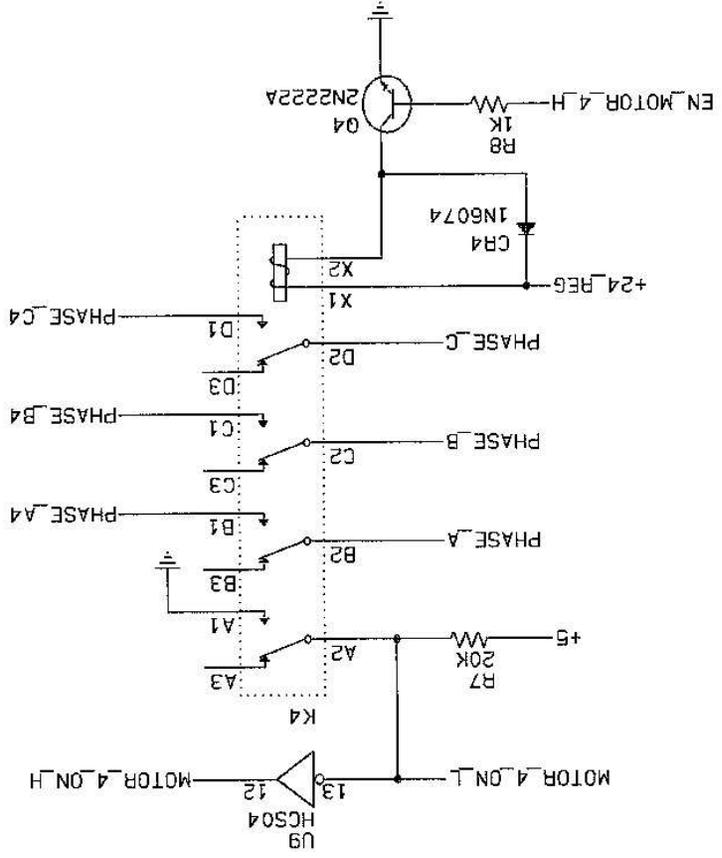
Relay failure is the most likely cause for the shutter insertion failure.

Tests identify the most-likely cause for the relay failure as particles, generated as a result of oxidation of the copper elements of the contact assembly during long-term storage in an oxidizing environment.

- Stop routine HRC door operation [Done]
- Remove mechanism commanding from HRC safing SCSS [Done]
- Increase frequency of bright UV source monitoring [Done]
- Stop use of the HRC shutters and calibration source
