2022 HRC Anomaly Status – CUC Briefing

Dan Patnaude

11/28/2022

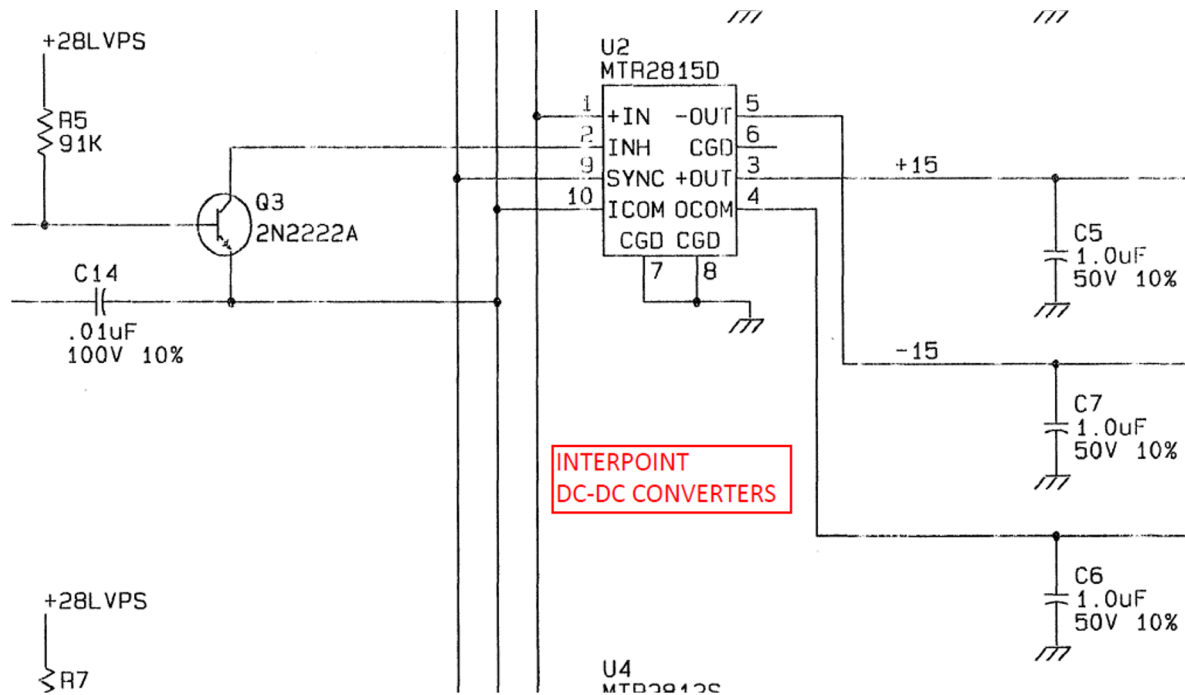
From: HRC-5299 LVPS

- Multi-Layer Ceramic Capacitor (MLCC) 50V, 1 μ F (M39014/02-1419)
 - There is one of these from each MTR2815D converter output in the CEA to filter out switching noise. There is no current limiting resistor in place
